PRINCESS PIER, TORQUAY

REPORT INTO CONDITION OF DECKING AND SUPPORT JOIST

Princess Pier, Torquay

Report into condition of decking and support joists

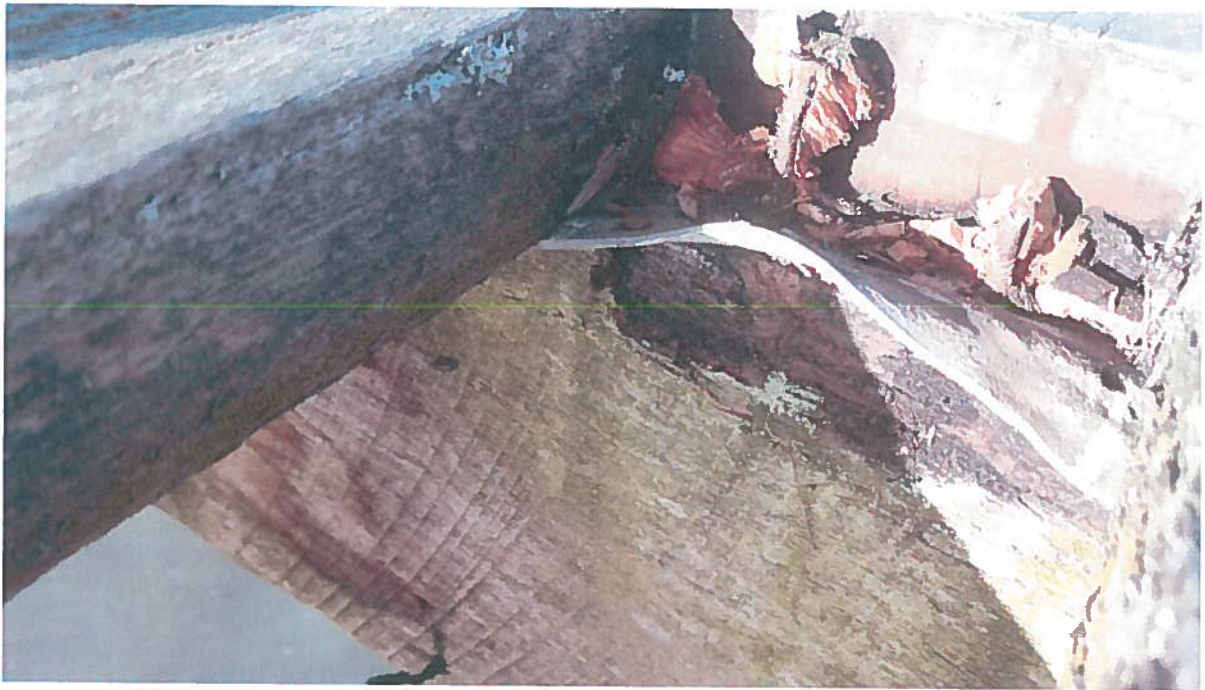
In lifting decking planks it was found that odd numbered joist numbers 1-59 had been covered on their upper face with lead strips. These joists were found typically to have lost little section size. Their alternates, and joist numbers 60-78 were found to be covered on their upper face with a bituminous membrane, typically defective with consequent loss of timber section at the joist-plank connection interface due to retained water.

Photo 2 Joist with lead sheet over and some defective timber

Joists 1-59 appear to currently offer sufficient residual life to remain in service for the time being. At the same time as any replacement of decking planks a waterproof membrane should be placed over even numbered joists, with localised replacement of any significantly defective joists. An estimate is offered, of 10 joists warranting such replacement. Minimally at plank replacement, the alternate joists in this section would usefully be covered in a waterproof membrane to render their degree of protection equal to that of their adjacent lead sheet-covered members. Some lead may be found to require replacement.

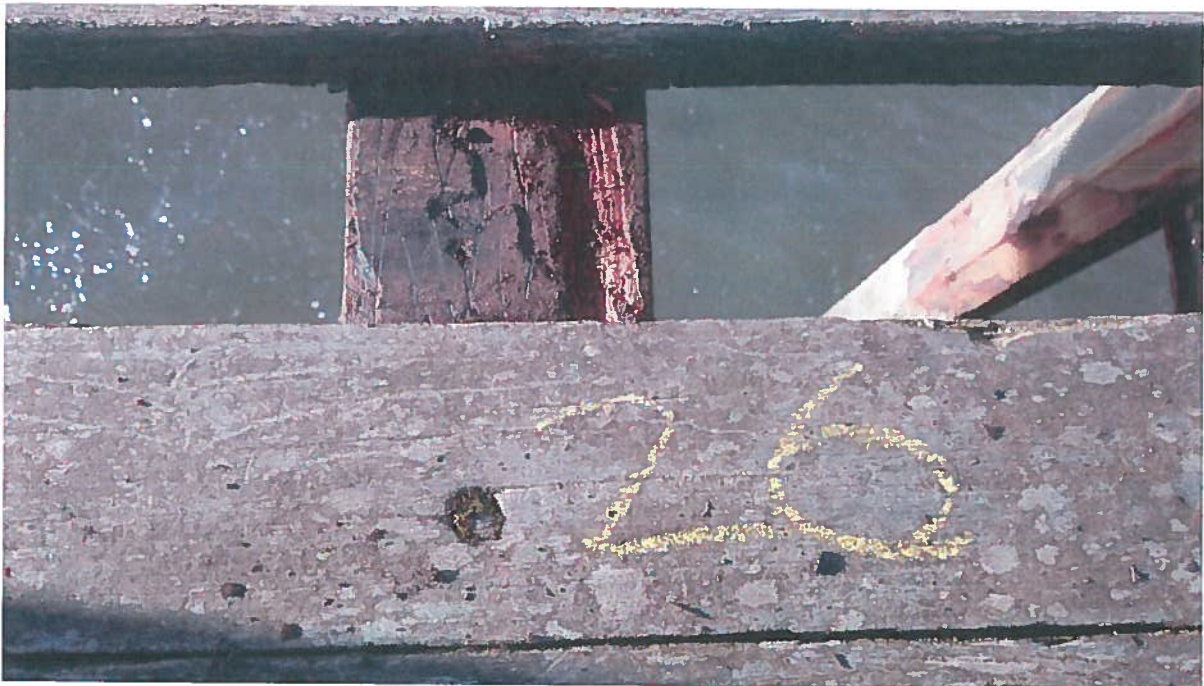
The sample has estimated mean stress of 0.643 under crowd loading, the 669 joist connections apparently being statistically capable of withstanding crowd loaded capacity. Joist no. 8 appears to be an exception, measured/calculated to be beyond capacity under crowd loading.

Photo 3 Joist 26 in fair condition. Stress estimated = 0.543

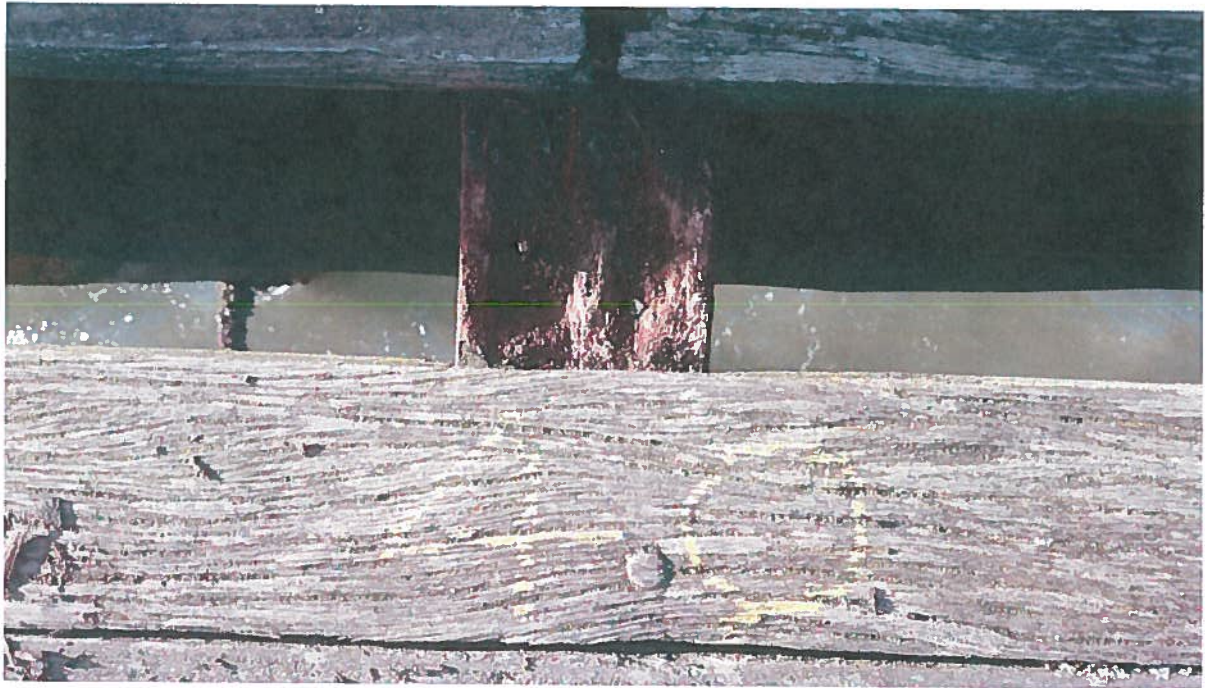
Photo 4 Joist 40 with moderate section loss. Stress estimated = 0.731

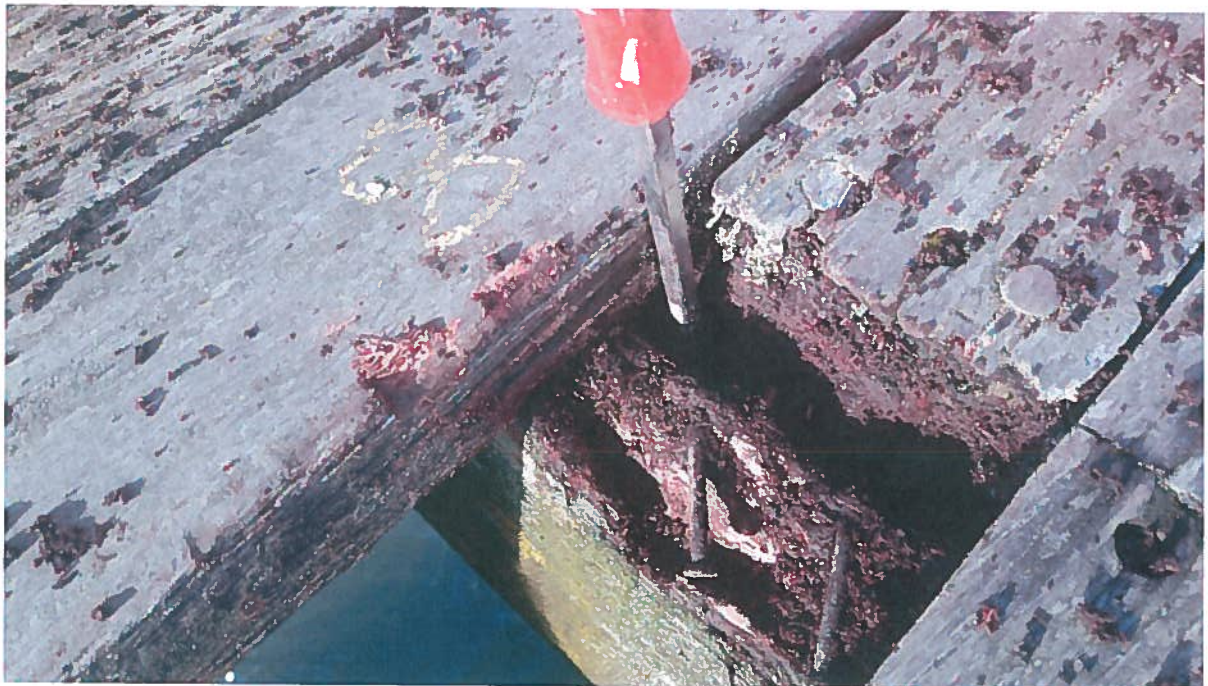
Photo 5 Joist 8 with significant loss. Stress estimated = 0.997

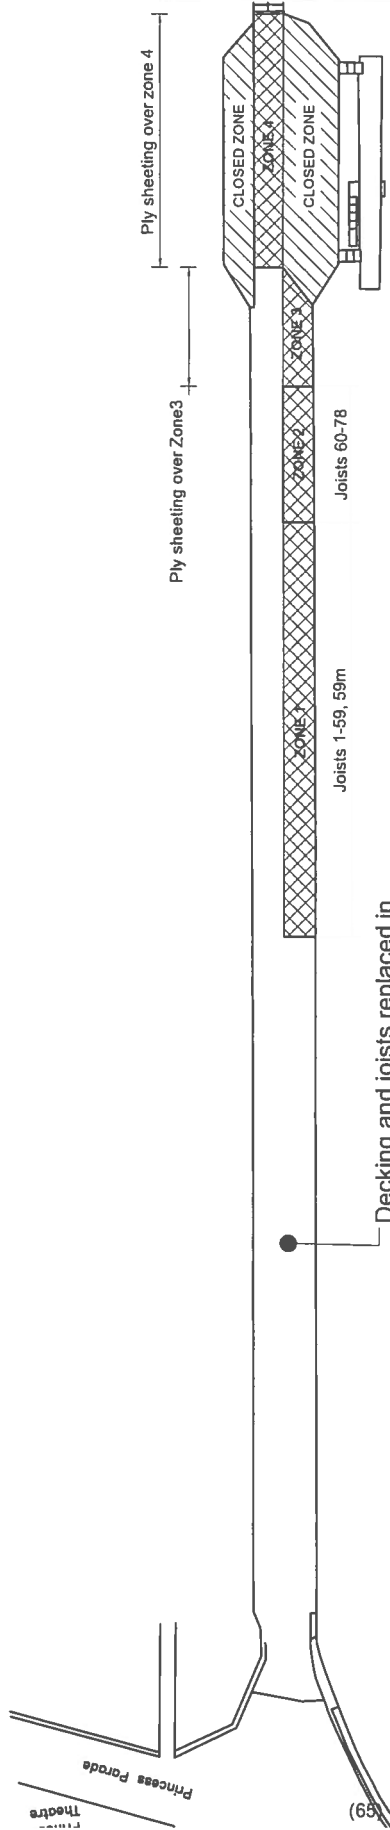
DRAWING NUMBER: 10/6/15_23 DATE: 10/6/15_23
PRINCESS PIER, TORQUAY				DRAWING TITLE: Princess Pier, Torquay
Decking Survey - Jan 15				DRAWING NUMBER: 10/6/15_23

Decking and joists to the majority of the Princess Pier boardwalk have been largely replaced in recent years; this report is limited to assessing the condition of decking support joists currently in use in the public domain at four zones, and as indicated in drawing 10/6/15_23.

The survey initially covered a span of 78 joists at the seaward side of the pier i.e. the side suspended over the sea by piled-supported framing. The surveyed area is towards the 'banjo' end of the pier and is indicated in drawing 10/6/15_23.

Decking and joists replaced in recent years
