Princess Pier, Torquay

Report into condition of decking and support joists

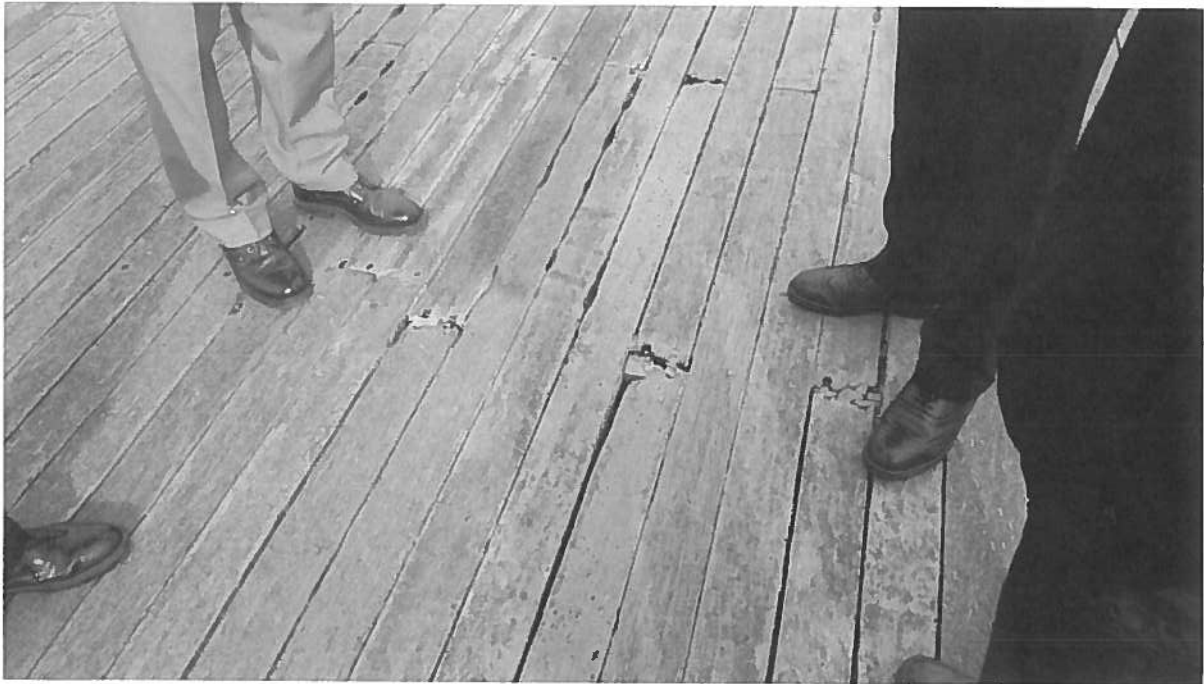
The decking planks over the whole of these areas are in very poor condition, two of the zones having been covered in ply sheeting. The remaining two exposed zones of planking require urgent address to repair, replace, or to similarly sheet cover.

Photo 1 Deck condition typically poor at plank ends, with repairs, traps, and potential trip hazards

The condition of decking planks over zones 1 and 2 is poor; these should be lifted and replaced. Some efficiency of cost may be achieved by harvesting sound lengths, estimated at 30-50%, but the zones under consideration in this report are the last remaining with planks of differing dimension to those on the zones where full replacement has already taken place.

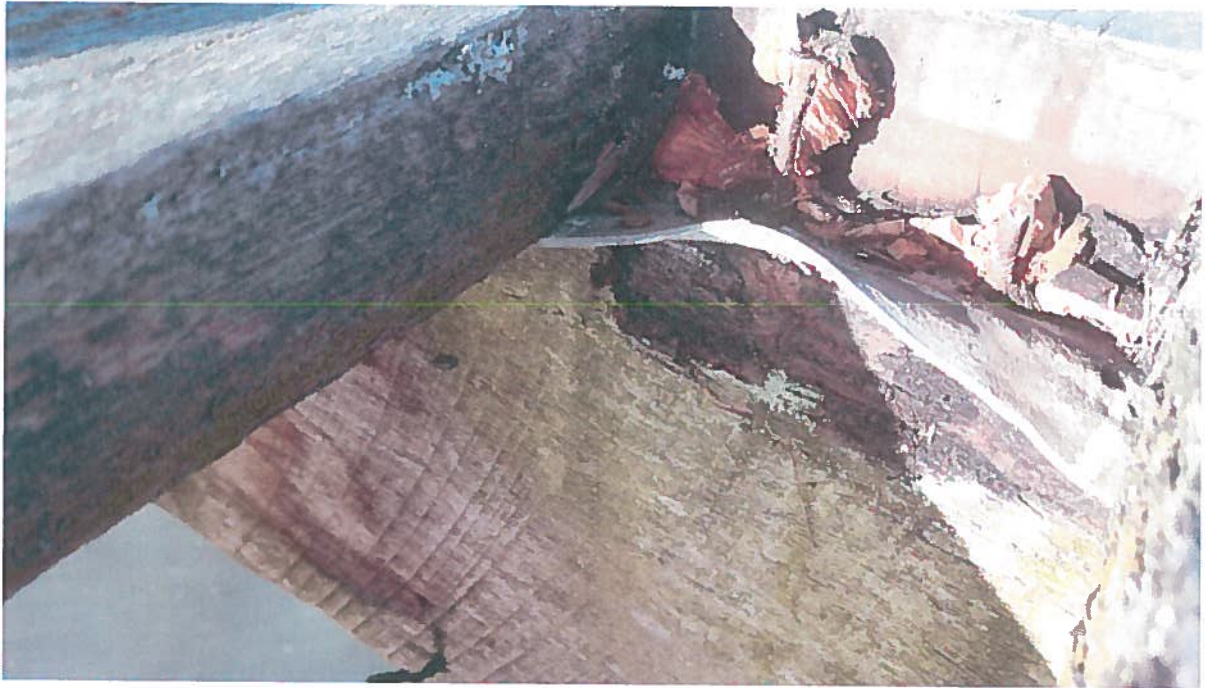
In lifting decking planks it was found that odd numbered joist numbers 1-59 had been covered on their upper face with lead strips. These joists were found typically to have lost little section size. Their alternates, and joist numbers 60-78 were found to be covered on their upper face with a bituminous membrane, typically defective with consequent loss of timber section at the joist-plank connection interface due to retained water.

Photo 2 Joist with lead sheet over and some defective timber

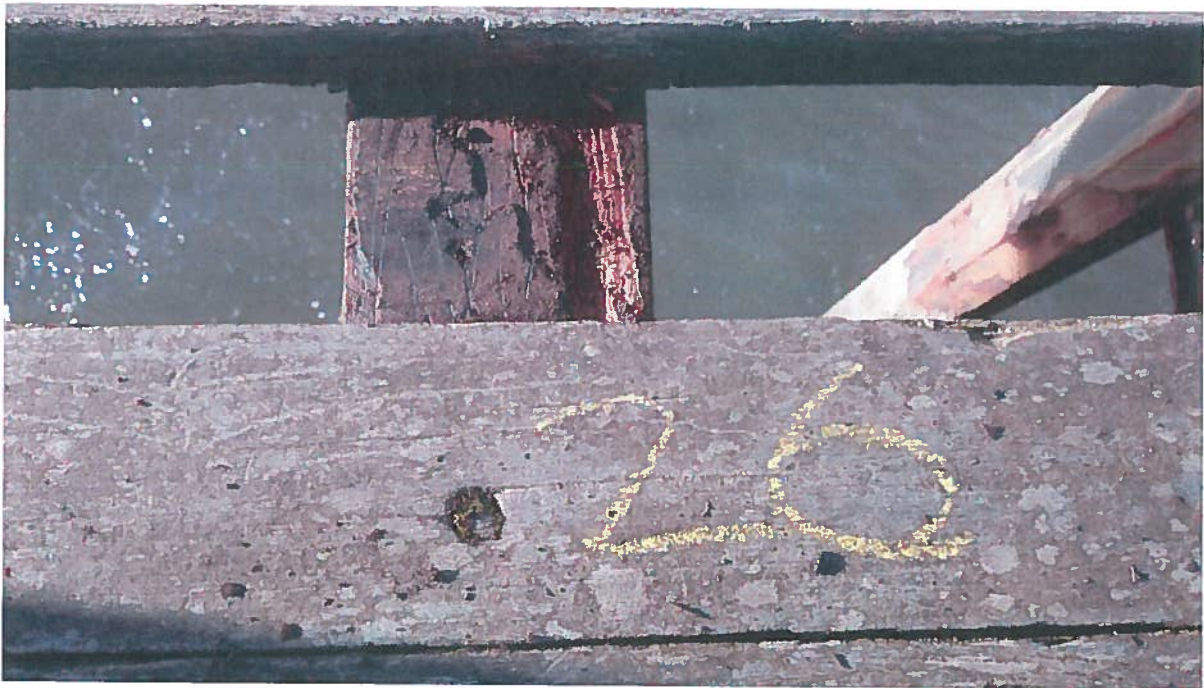
Photo 3 Joist 26 in fair condition. Stress estimated = 0.543

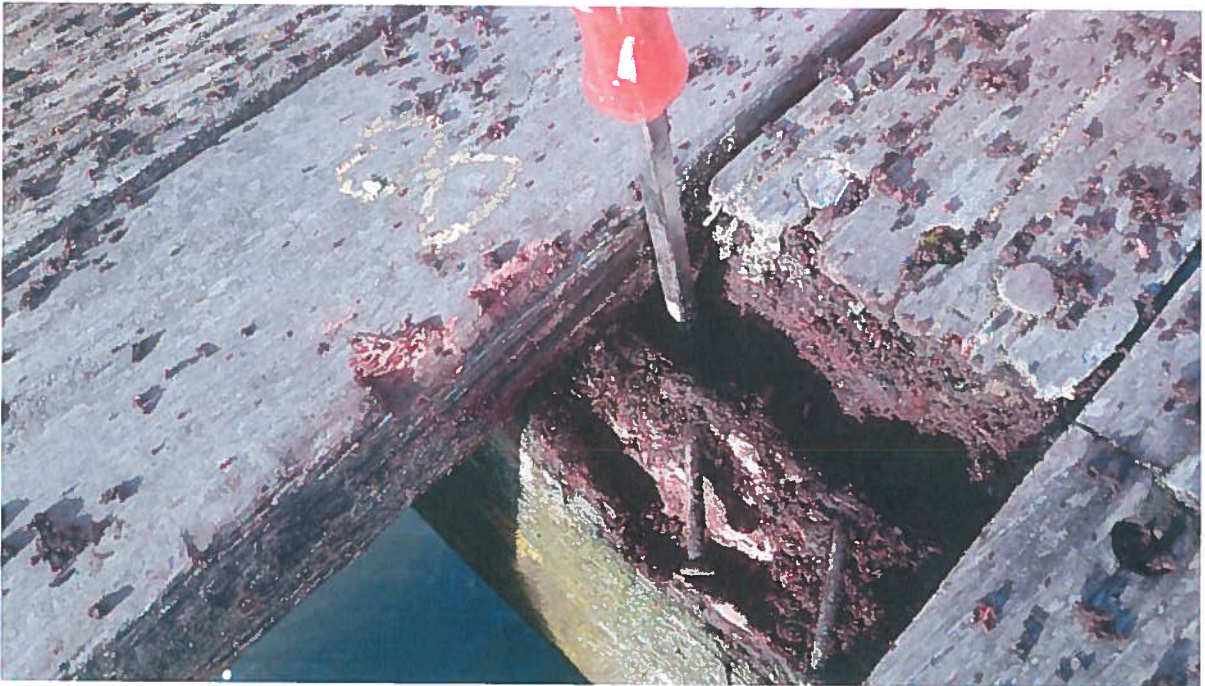
The sample has estimated mean stress of 0.643 under crowd loading, the 669 joist connections apparently being statistically capable of withstanding crowd loaded capacity. Joist no. 8 appears to be an exception, measured/calculated to be beyond capacity under crowd loading.

Photo 5 Joist 8 with significant loss. Stress estimated = 0.997

Joists 1-59 appear to currently offer sufficient residual life to remain in service for the time being. At the same time as any replacement of decking planks a waterproof membrane should be placed over even numbered joists, with localised replacement of any significantly defective joists. An estimate is offered, of 10 joists warranting such replacement. Minimally at plank replacement, the alternate joists in this section would usefully be covered in a waterproof membrane to render their degree of protection equal to that of their adjacent lead sheet-covered members. Some lead may be found to require replacement.
