Princess Pier, Torquay

Report into condition of decking and support joists

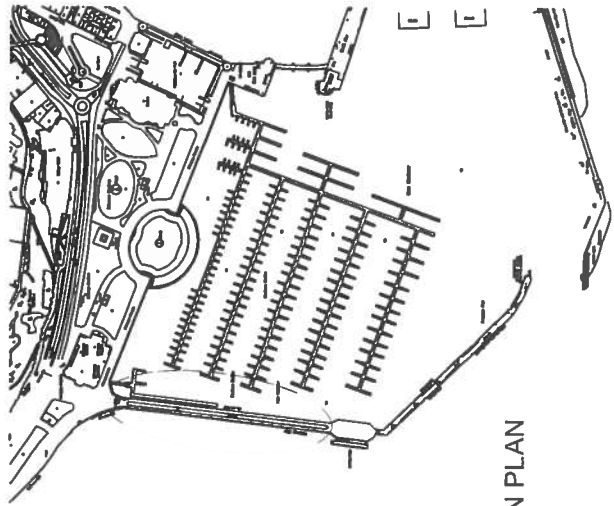
LOCATION PLAN

Decking and joists to the majority of the Princess Pier boardwalk have been largely replaced in recent years; this report is limited to assessing the condition of decking support joists currently in use in the public domain at four zones, and as indicated in drawing 10/6/15_23.
